Woods Pond Watershed-Based Protection Plan

April 2013

Fiddlehead Environmental Consulting

Woods Pond Watershed Survey

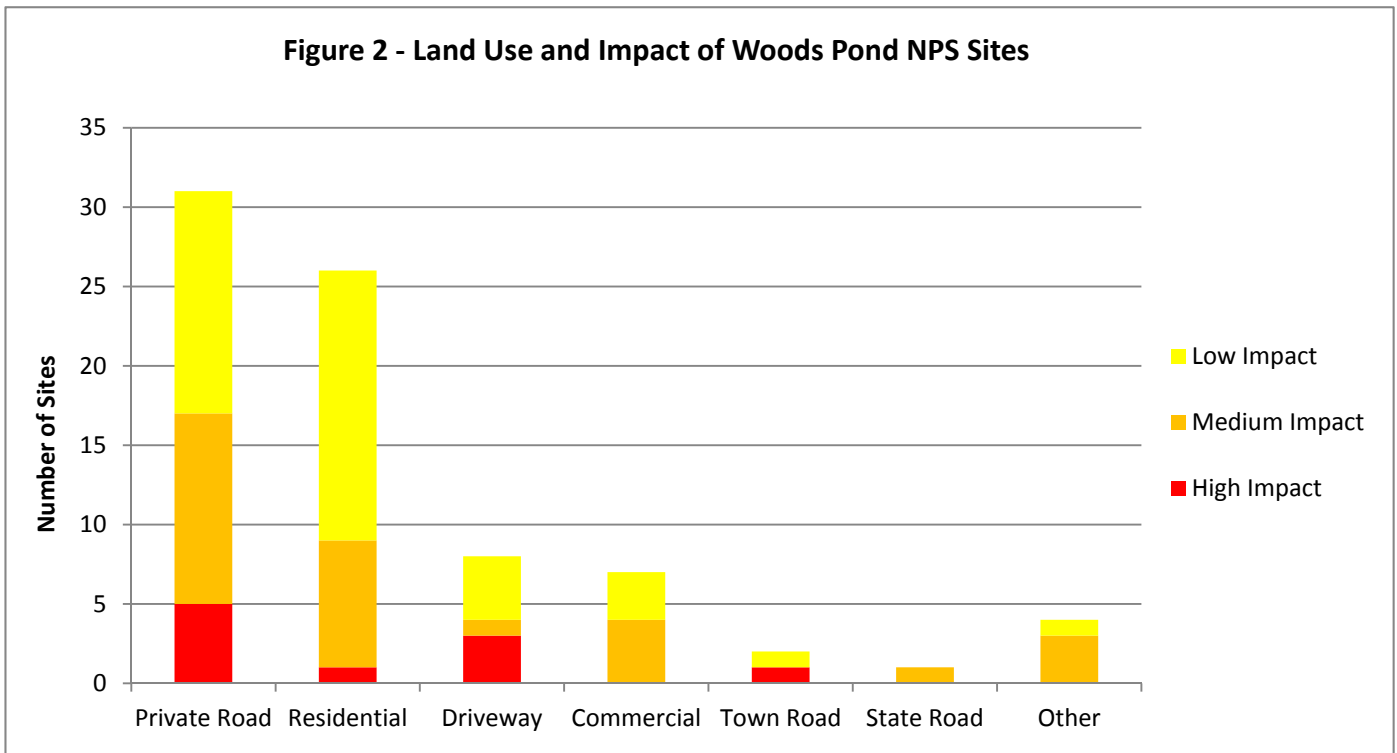
Figure 2 - Land Use and Impact of Woods Pond NPS Sites

In total, 79 erosion sites were identified in the watershed (Figure 2 and Table 1). The largest numbers of problems were associated with private roads (31 sites), residential properties (26 sites), driveways (8 sites) and commercial properties (7 sites). The remaining 7 sites were associated with 2 town roads, 2 paths, 1 beach, 1 state road and 1 construction site. Aside from soil erosion, no other significant sources of phosphorus were observed during the survey.

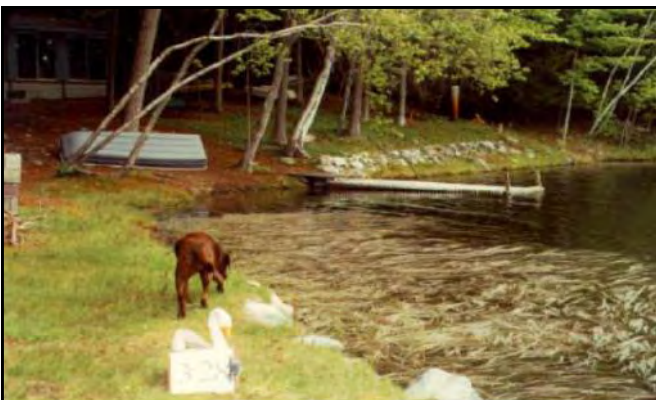
*Several lakeshore properties were observed to have little or no **vegetated buffer** at the water's edge. It is important to note that buffers of shrubs and trees do a much more effective job than bare ground or grass at keeping NPS pollution from entering lakes. Deep shrub and tree roots also help hold the shoreline.*

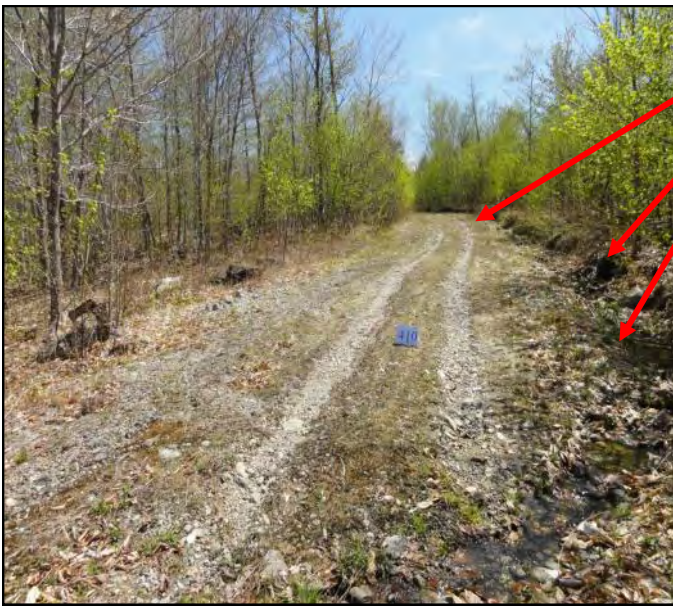
Problems:

- Poor shaping (no crown and two tracks have developed).
- Ditch backslope erosion.
- Water flows over road causing erosion.

Solutions:

- Install rock armor around the culvert outlet.
- Properly shape shoulder and build up road.
- Install plunge pool at culvert outlet.

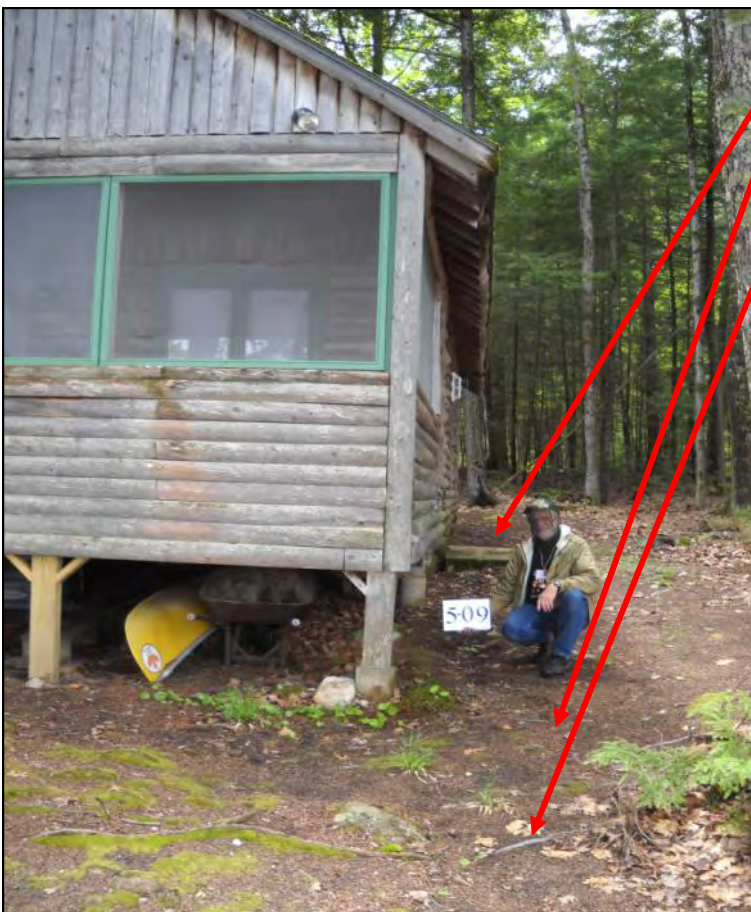
Problems:

- Roof runoff causes erosion.
- Bare soil is exposed to the erosive force of snow and rain.
- Exposed roots indicate heavy foot traffic that increases erosion.

- Install an infiltration trench beneath the roof dripline.
- Apply erosion control mulch on bare areas or plant with grass and shrubs in sunny spots.
- Define and narrow the foot path to reduce erosion.

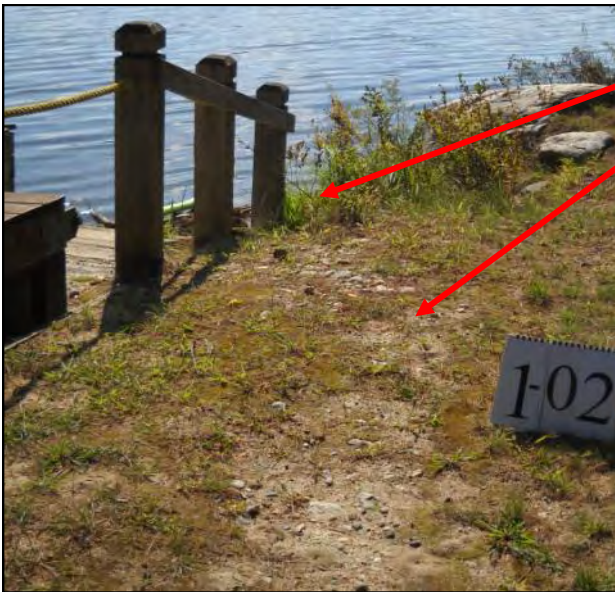
Problems:

- Inadequate buffer where erosion washes into lake.
- Eroded material flows to lake.

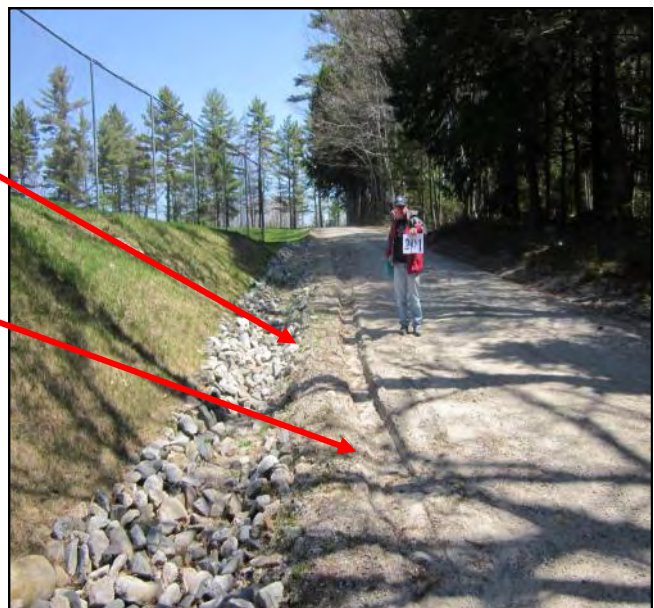
Problems:

- Berm traps storm water on the road which causes erosion.
- Rut in road indicates that the road is not crowned.

Solutions:

- Remove berm to allow runoff to enter the ditch.
- Properly crown the road.

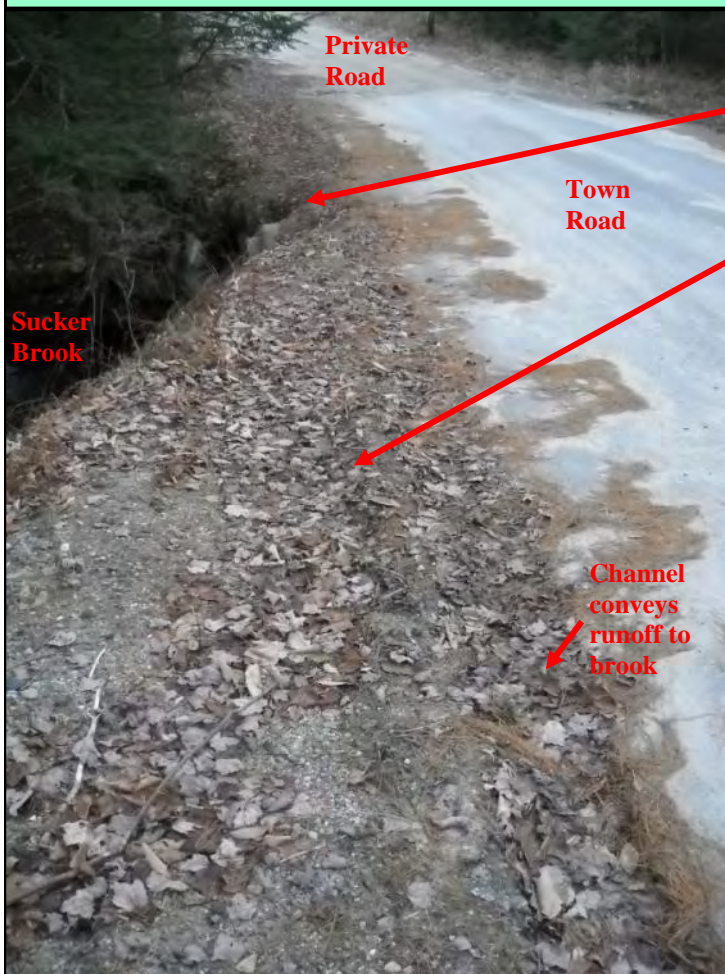
This is a particularly problematic erosion site where Wildwood Road crosses Sucker Brook. The town and private road association will need to work together to solve this problem.

Problems:

- Deteriorating road above the culvert creates a direct path for eroding material to enter the brook.
- Berm traps water on the shoulder and has created a channel to the brook.

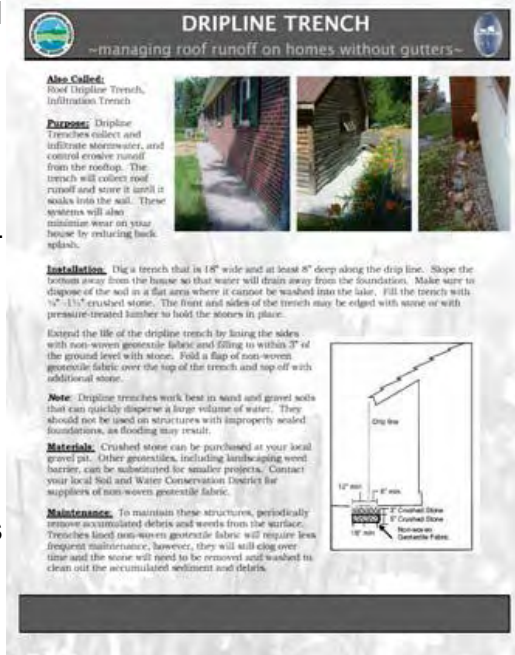
Fact sheets are available to help you install conservation practices on your property. Download at <http://www.maine.gov/dep/land/watershed/materials.html>

Rubber Razor—Use this structure in a gravel driveway or camp road. It can be plowed over only if the plow operator is aware of its presence and lifts the plow blade slightly. Place it at a 30 degree angle to the road edge and direct the outlet toward a stable vegetated area.

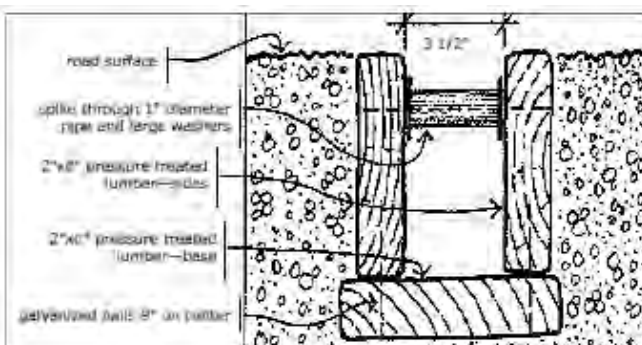
Open Top Culvert— Use this structure in a gravel driveway or camp road that does not get plowed in the winter. Place it at a 30 degree angle to the road edge and point the outlet into stable vegetation. Remove leaves and debris as needed.

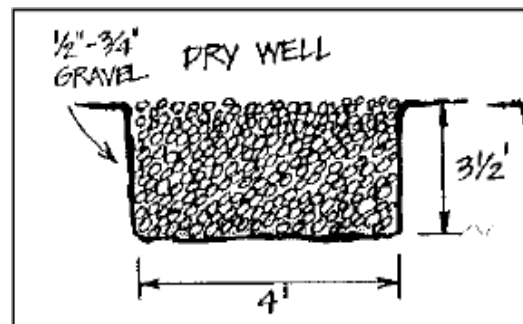
Drywell—Use a drywell to collect runoff from roof gutter downspouts. Drywells can be covered with sod or left exposed for easy access and cleanout. Drywells and infiltration trenches work best in sandy or gravelly soils.
